U.S. Fish and Wildlife Service

Humboldt Bay National Wildlife Refuge
Humboldt County, California

Lanphere Dunes Restoration Photodocumentation

June 2017

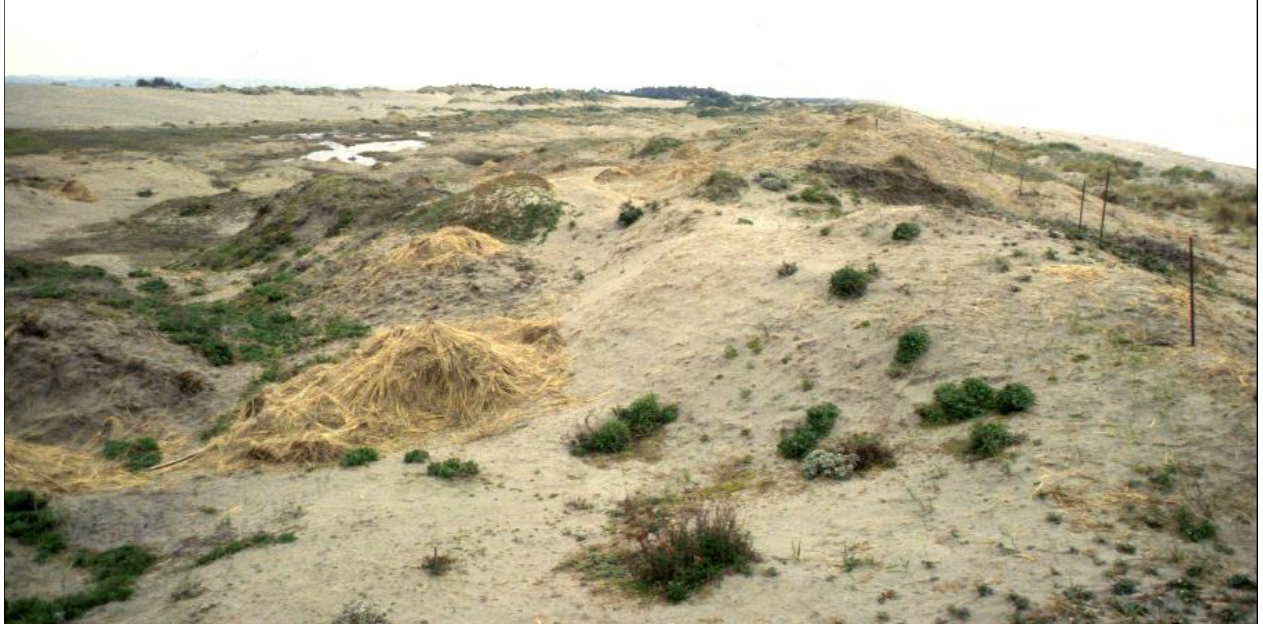
1995

The crest and lee of the foredune just after beachgrass removal in Phase 3. Areas that were treated in earlier phases already have native plants already returning.

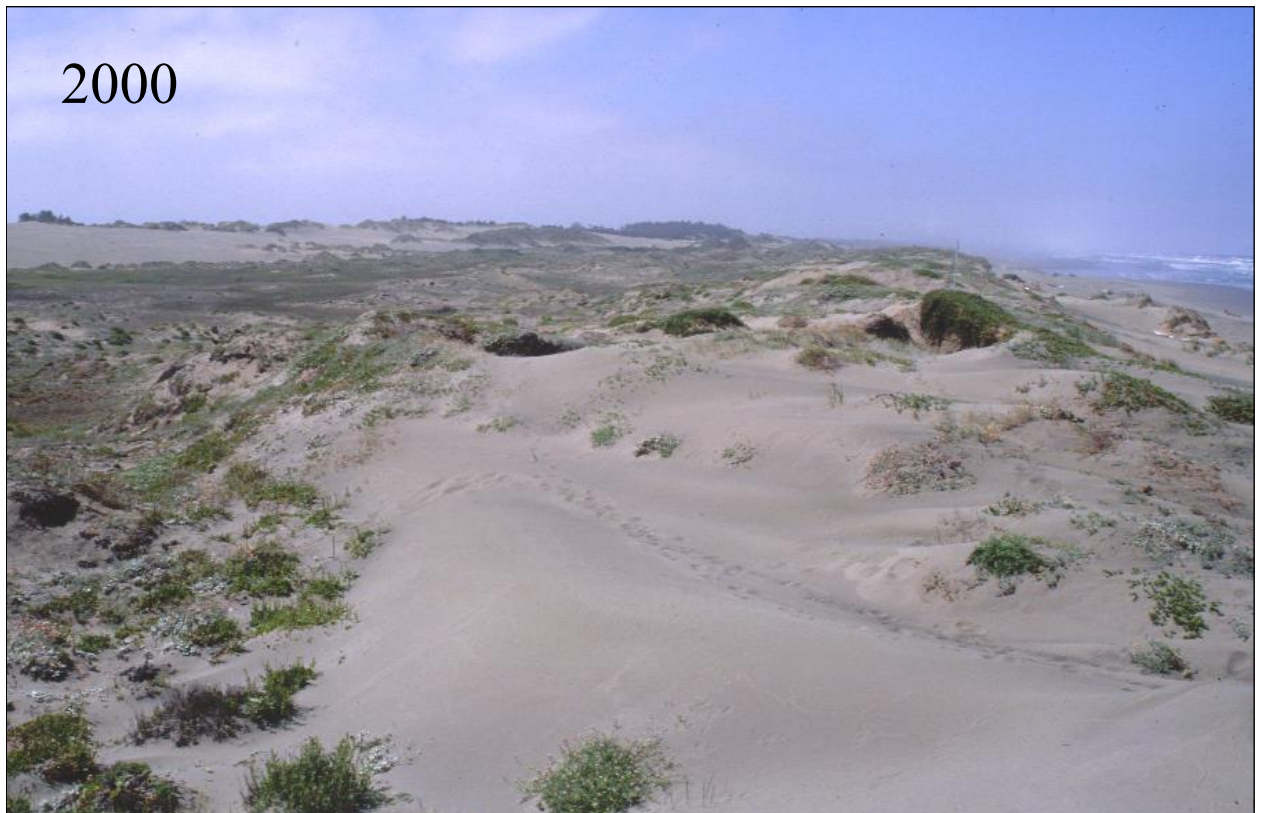
2000

A year and a half after the 1998-99 La Niña, a slipface is forming. Although not visible in this photo, the incipient foredune had been removed in this location. Sand is now being transported directly from the beach to the foredune, burying vegetation.

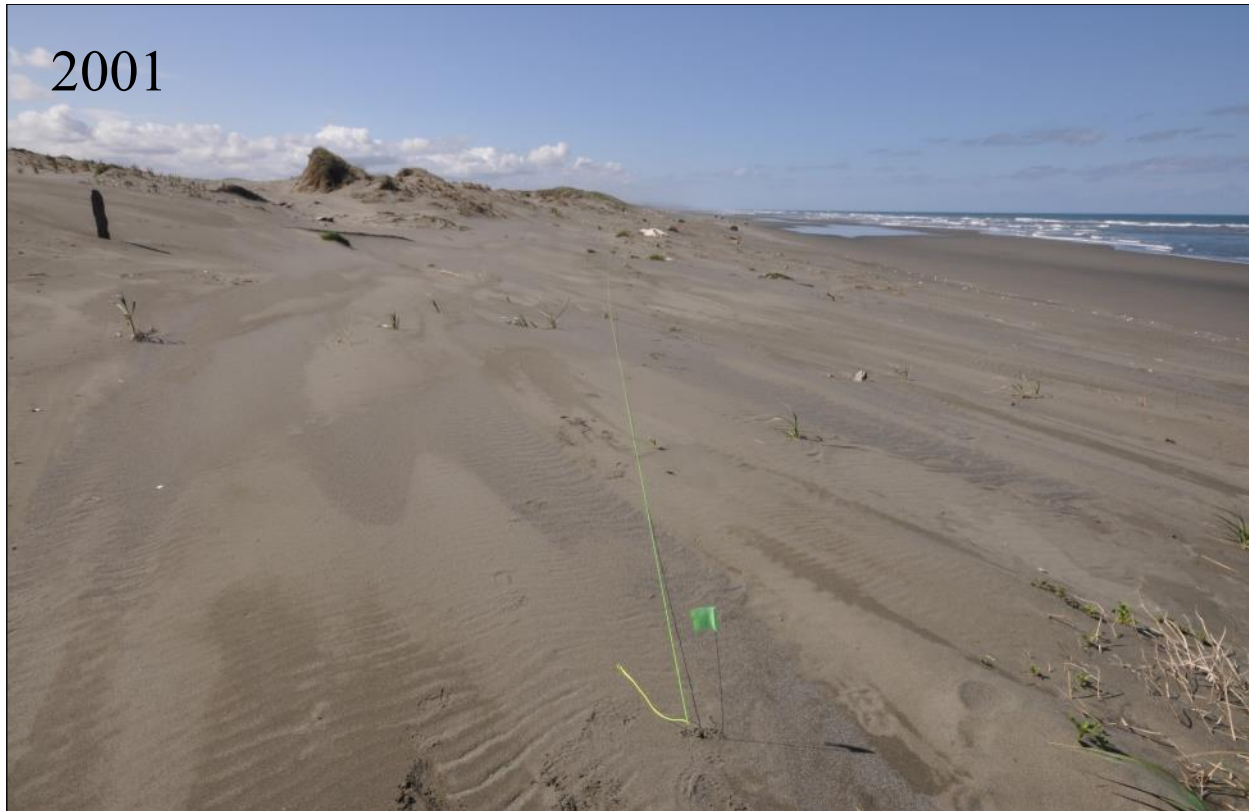
Photopoint 6a continued

This photograph was taken from a different vantage point on the upper beach farther west and south of the previous photos, but illustrates that by 2011 the foredune had completely eroded and was devoid of vegetation.

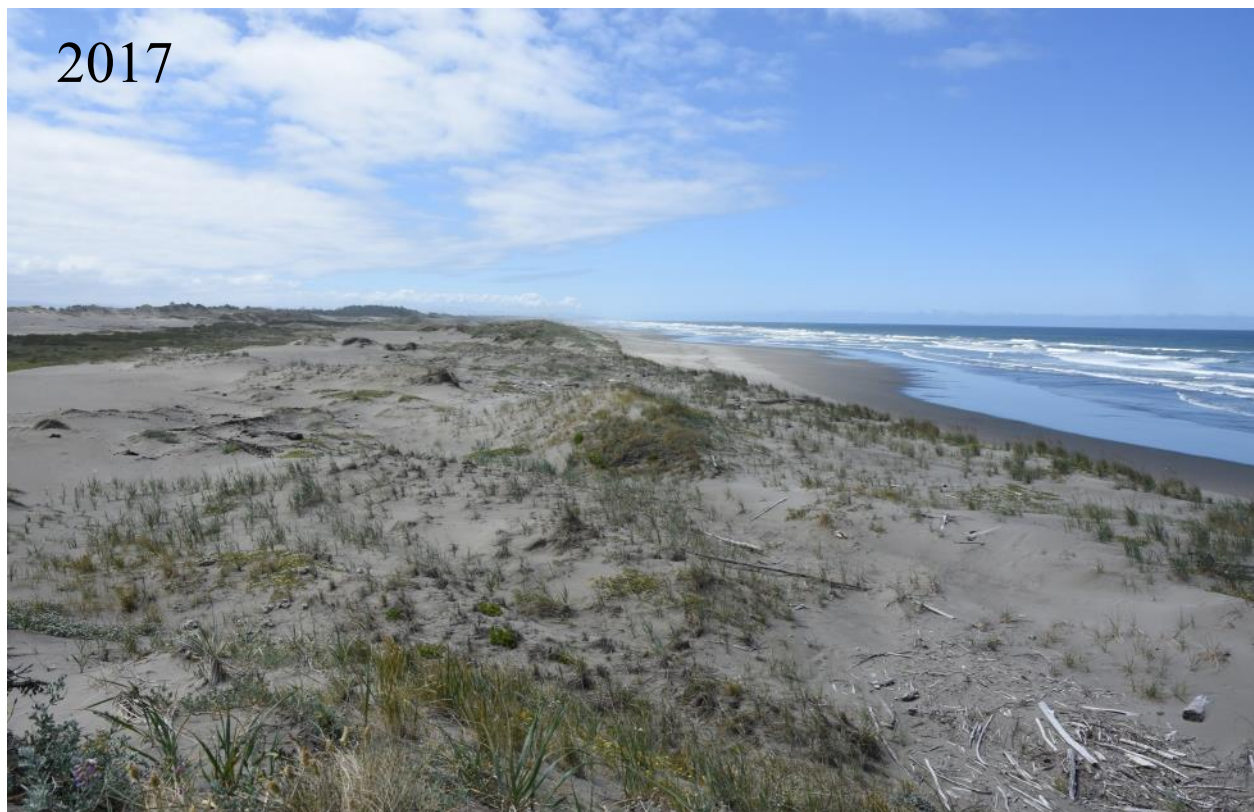
In 2011, the top of the upper beach was planted with 6 rows of American dunegrass. Since that time, an incipient foredune has formed (right) and the foredune is rebuilding (center). The slipface of the transgressive dunefield is now off the photograph to the left.

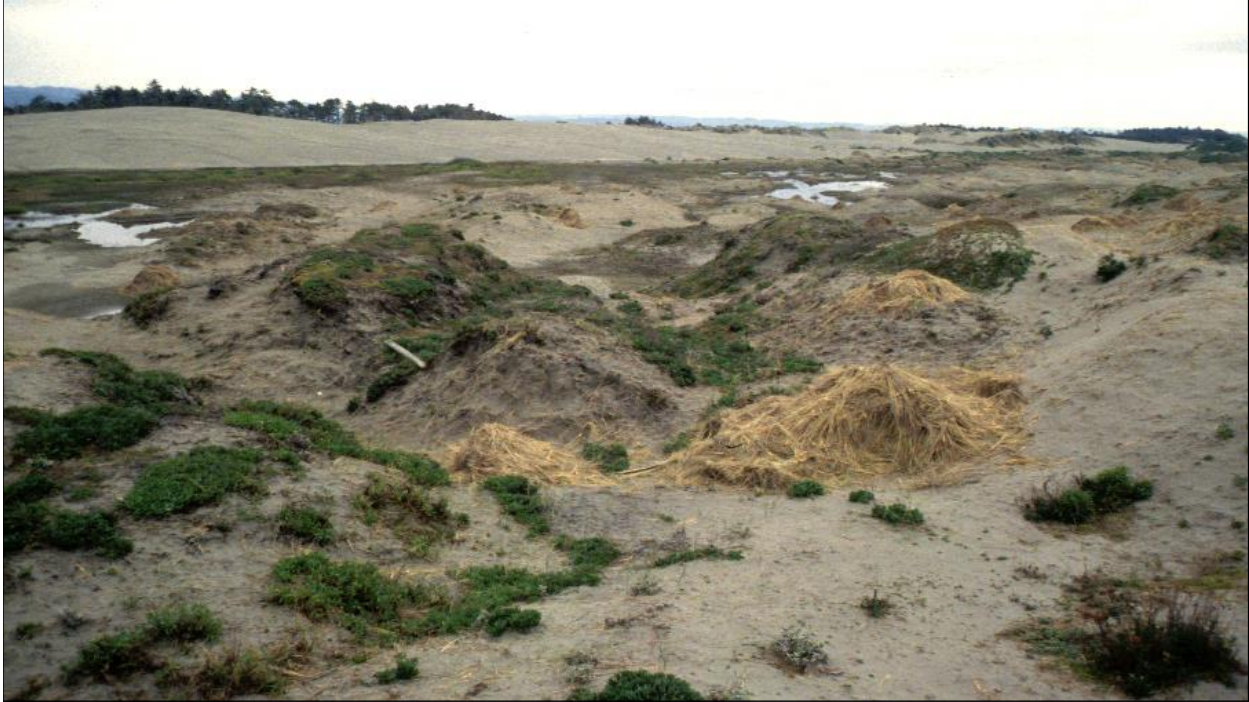
1995

This photo was taken from the same vantage point as 6A, but to the southeast rather than directly south, showing the lee of the foredune and ridges and swales to the east. Native plants have colonized the Phase 1 and 2 areas.

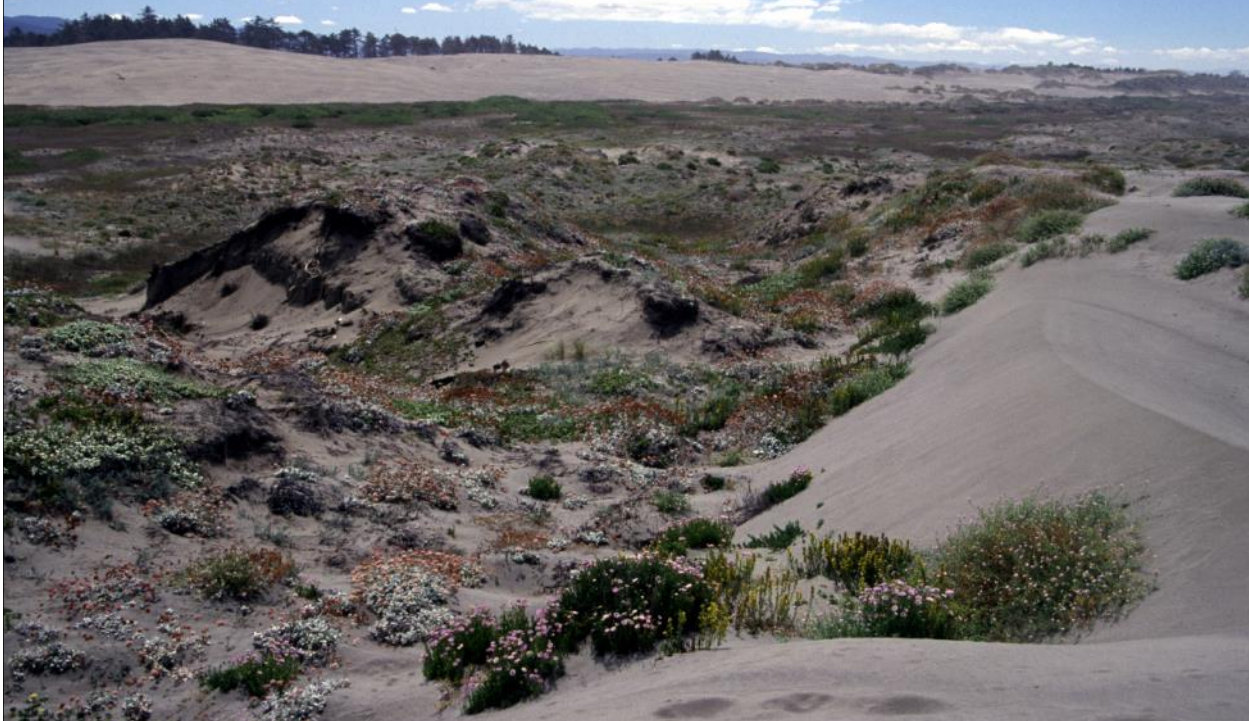
2001

As shown in the previous photopoint (6A), a slipface has formed and is migrating eastward.

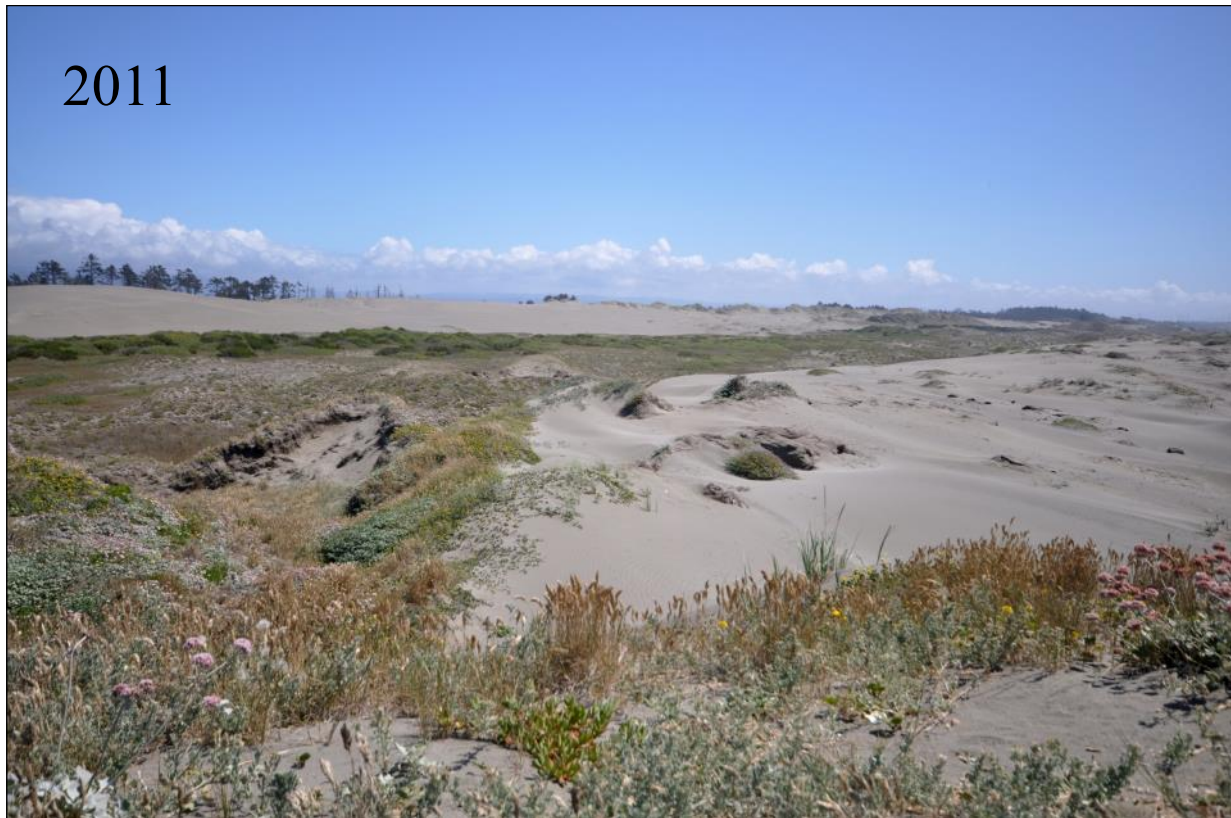
Photopoint 6b continued

The transgressive dunefield has formed and migrated farther east.

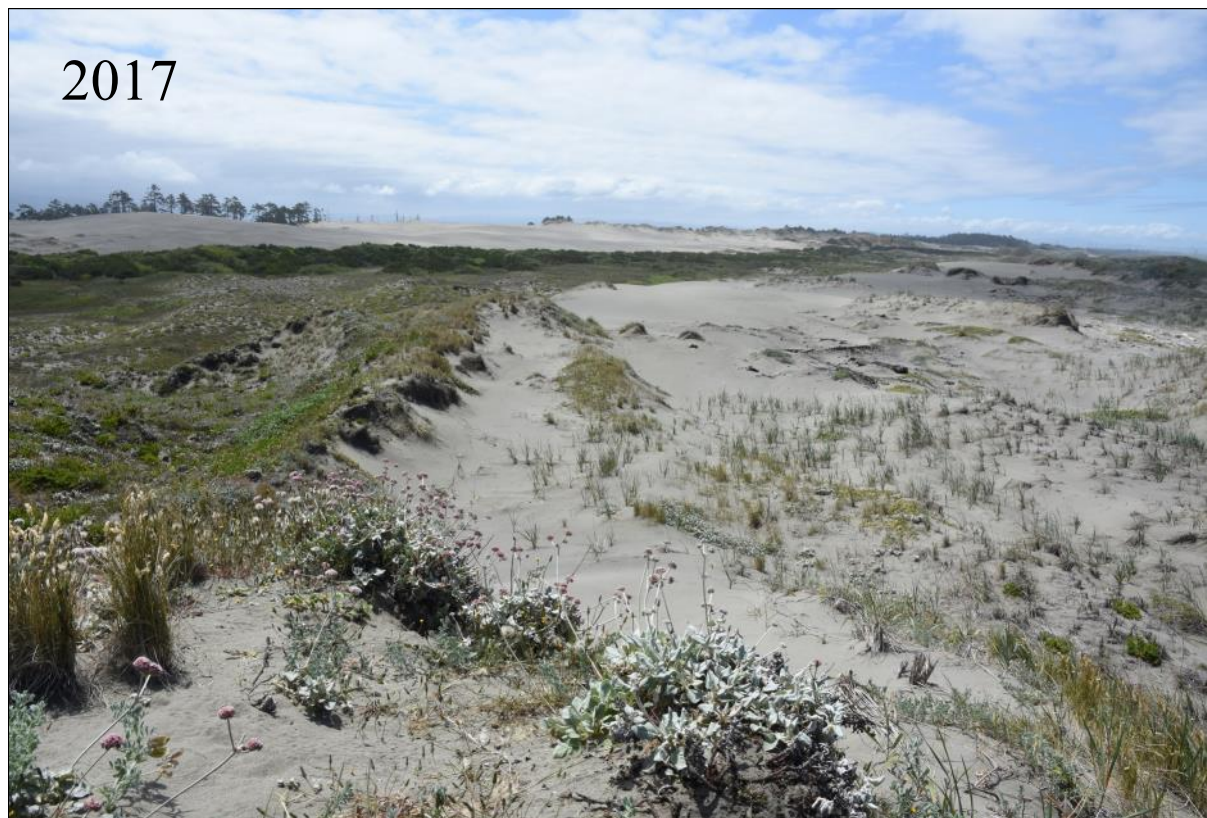
Although the eastern portion of the dunefield is still migrating, the rate of migration has slowed. American dunegrass and other dune mat species are colonizing the dunefield.

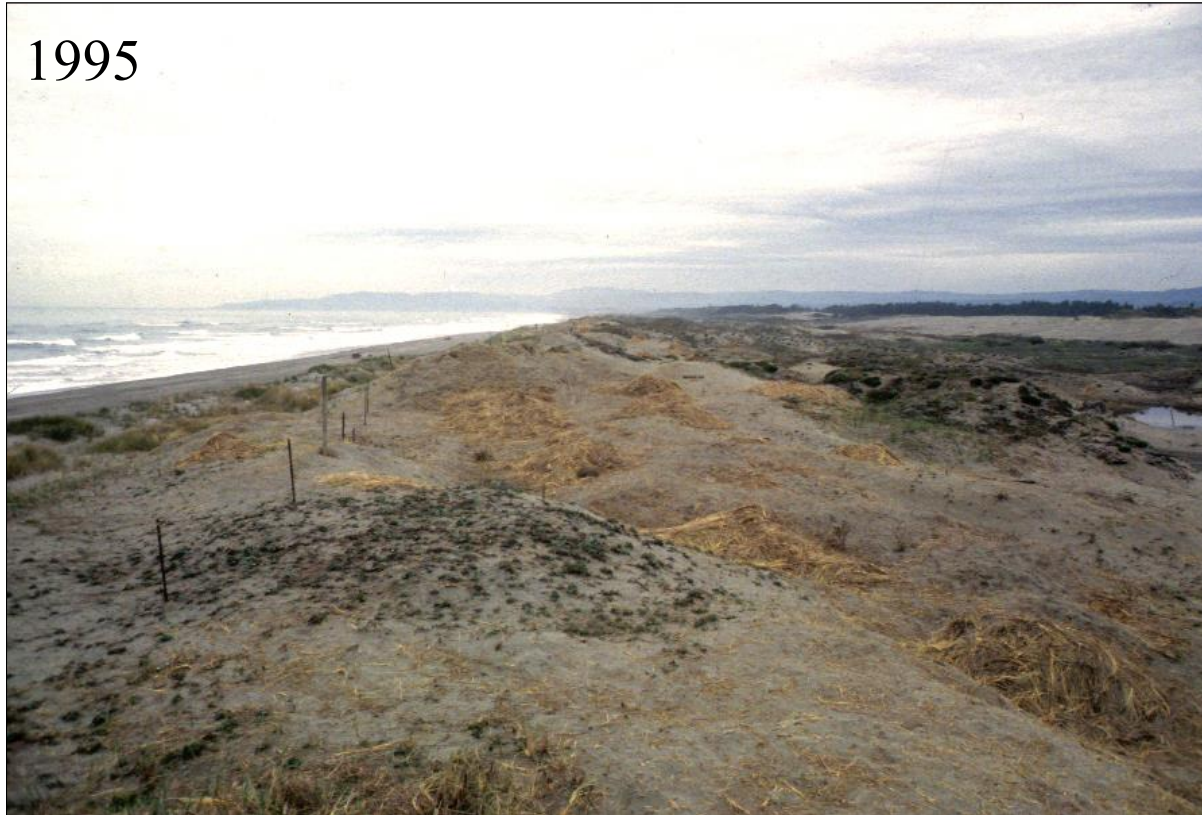
Photopoint 6c

The established and incipient foredune, taken just after beachgrass removal in Phase 3. Native vegetation in the centerground has returned in a small area treated in earlier phases.

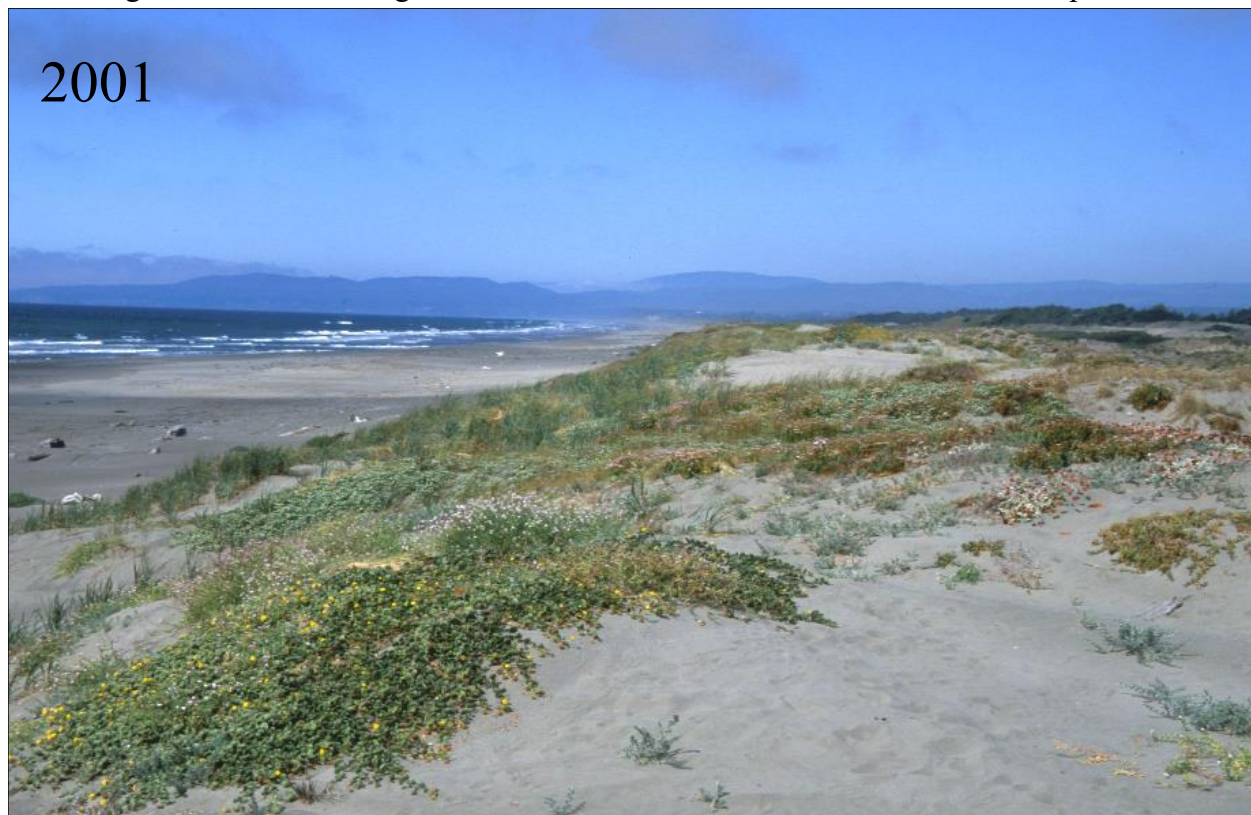
Native plants have vegetated the seaward face of the foredune, with an open area of blowing sand now on the lee face (lower right). The incipient foredune has eroded.

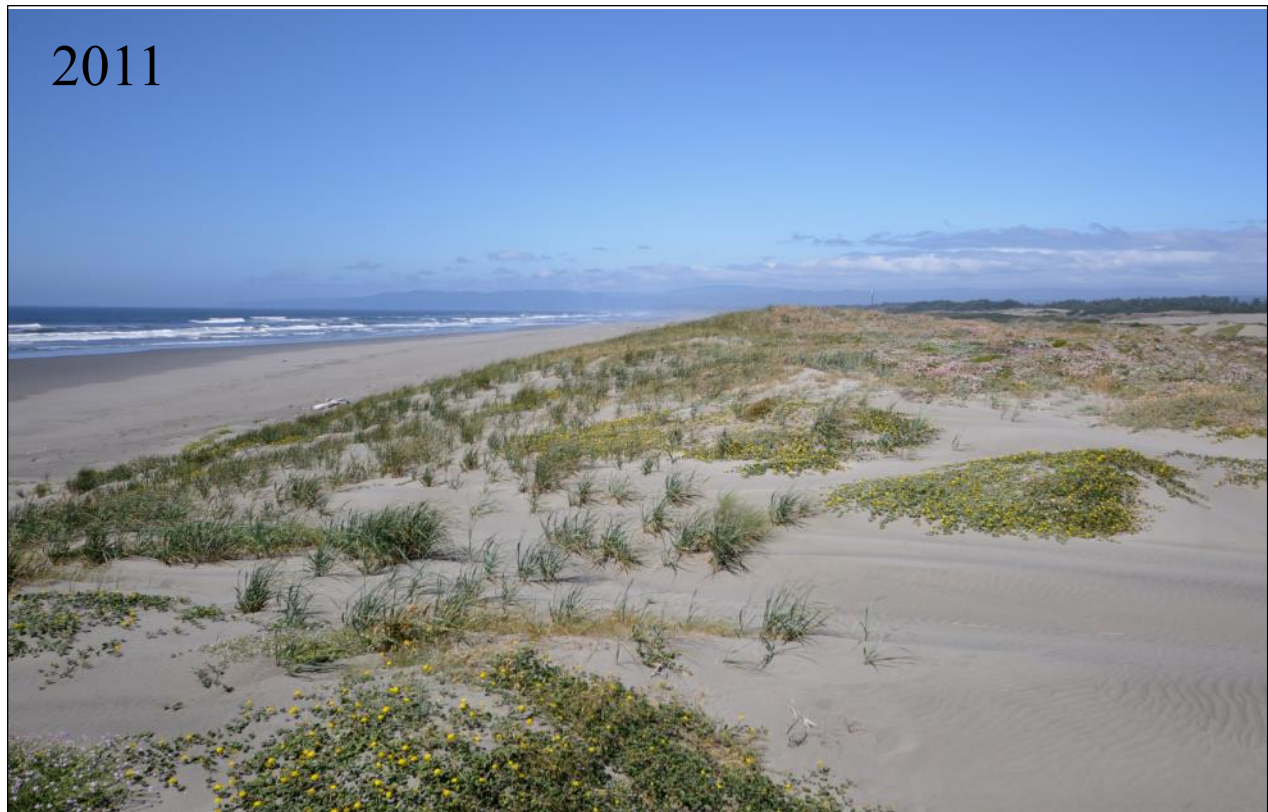
Photopoint 6c continued

The foredune has accreted to the west, although not as a distinct incipient foredune. The open area in lower right is now the upwind end of a blowout.

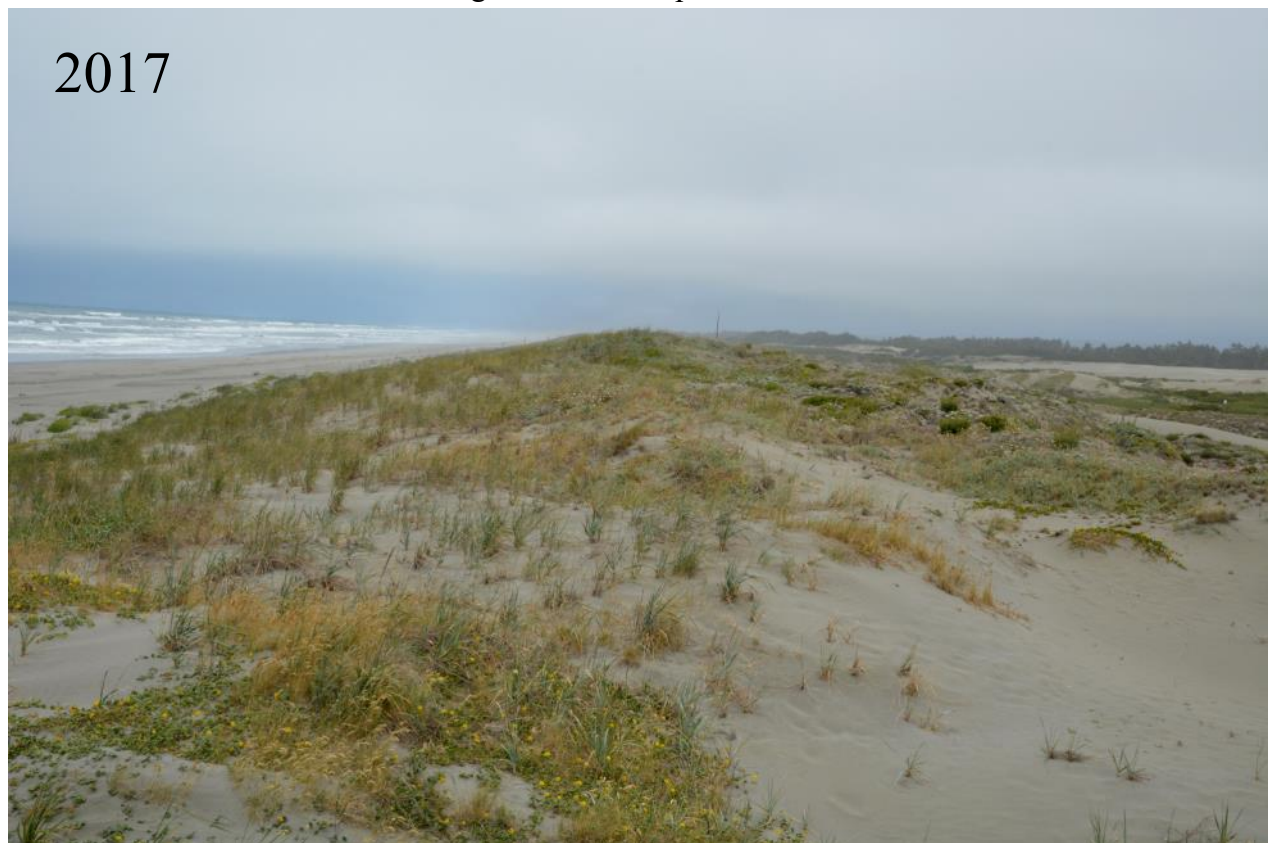
The foredune has increased in height as vegetation cover on the shoreward face has increased in density. The blowout area is still present in lower right.

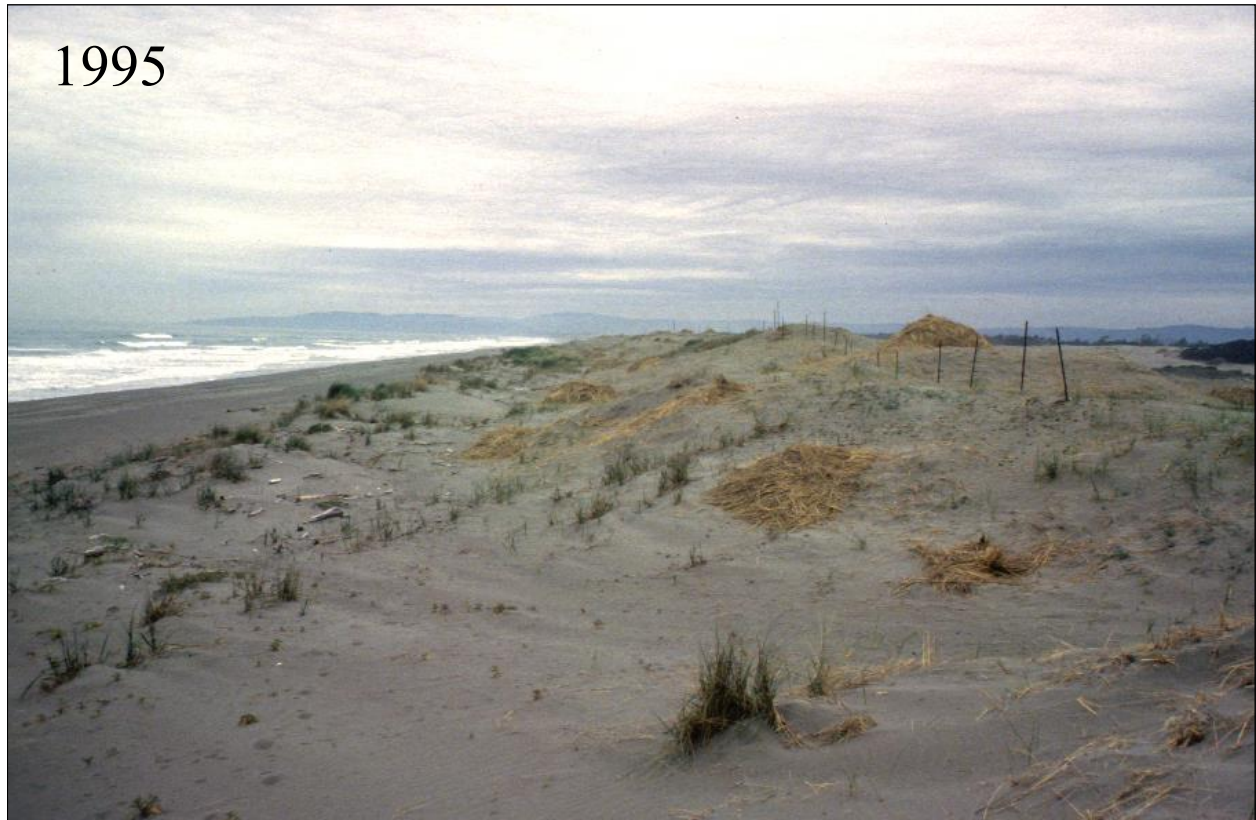
Photopoint 11

Phase 3 removal had just occurred when this photo was taken, although European beachgrass was still present on the incipient foredune.

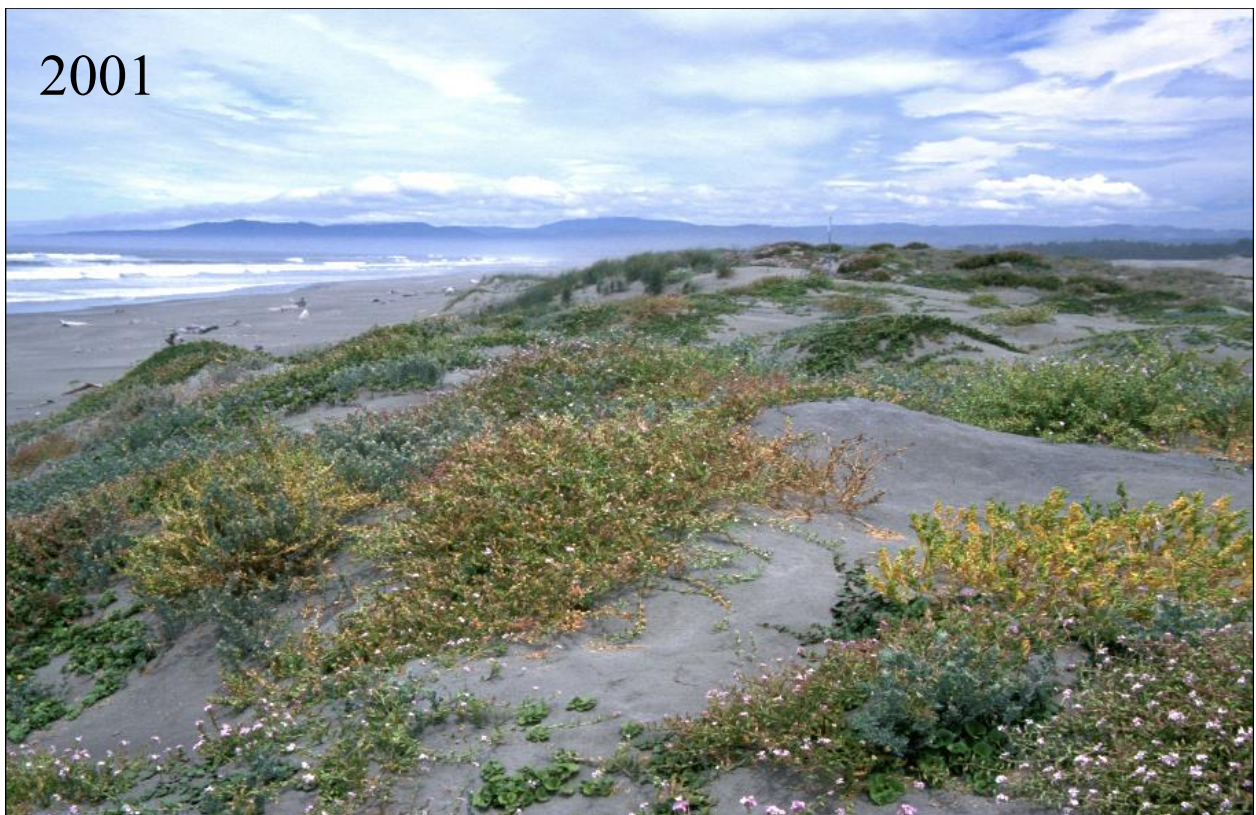
The foredune is covered by some native species (beach pea and beach morning glory) with several large plants of sea rocket, a non-native species that doesn't persist after restoration. The incipient foredune was removed during the 1998-99 La Niña.

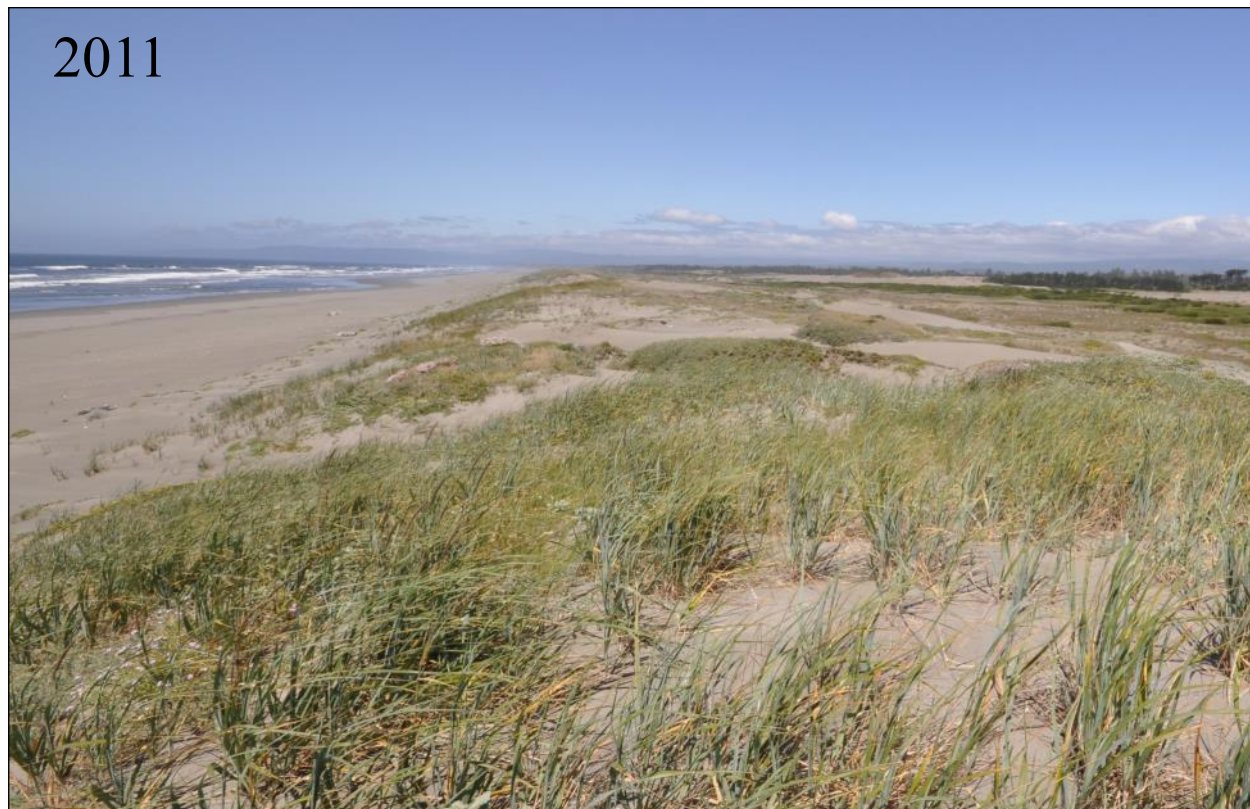
Photopoint 11 continued

The foredune has become largely colonized by American dune grass. An incipient foredune is reforming, and a blowout has developed in the middle-ground behind the foredune crest.

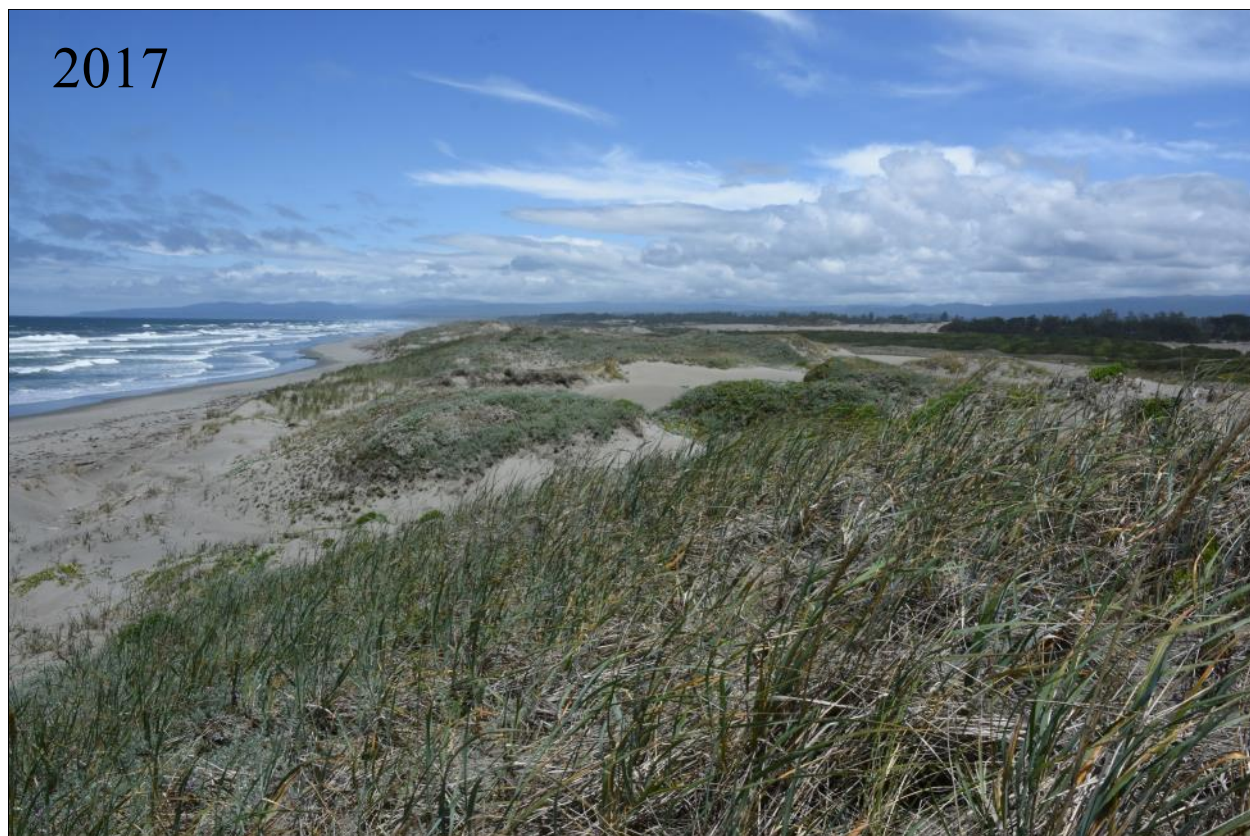
American dune grass continues to dominate the foredune crest. The incipient foredune is broader but not densely vegetated. The blowout in the centerground has continued to develop.
